SUN FLORIDA HOME INSPECTIONS, INC.

PROPERTY POST CLAIM FORM

Kissimmee, FL 34743

08/21/2025

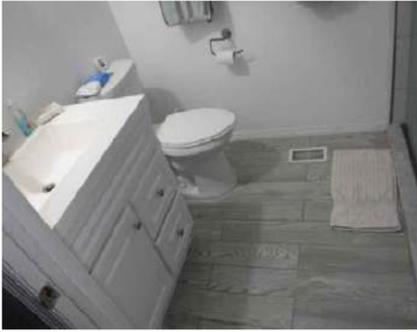
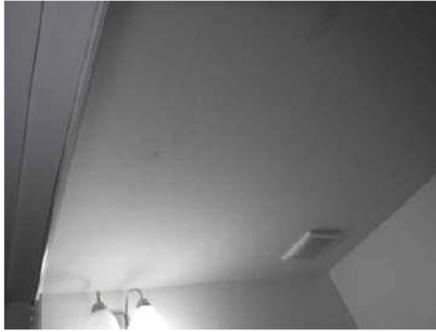
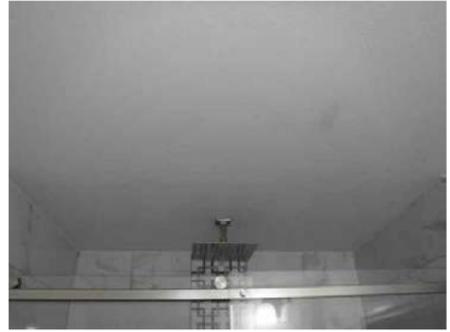
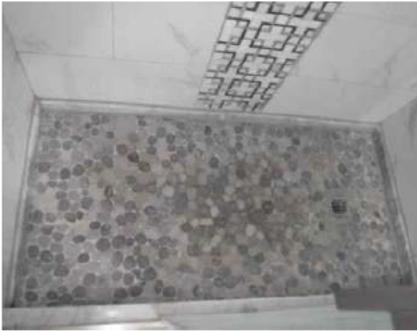
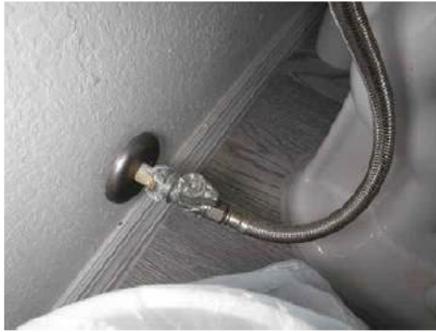
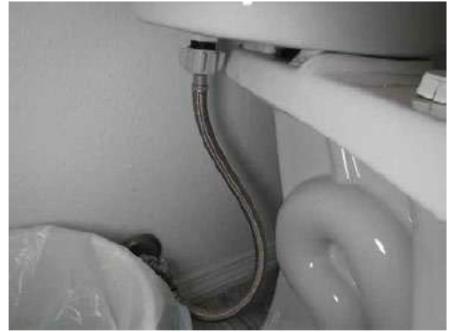
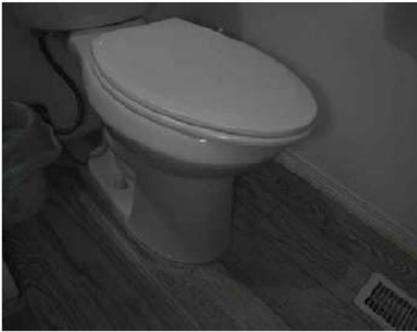
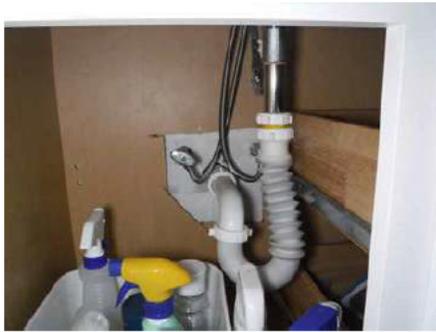
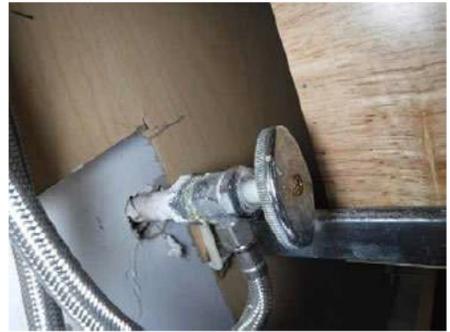
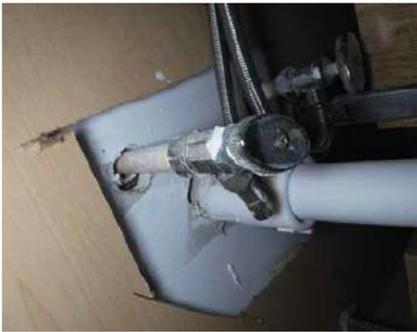
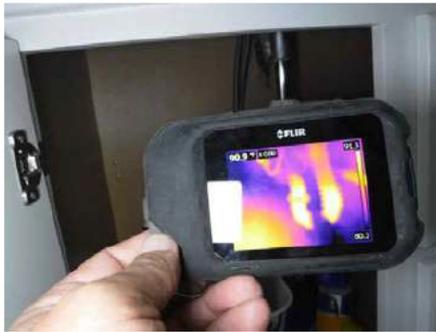
Master Bathroom

Repaired by building standard practice

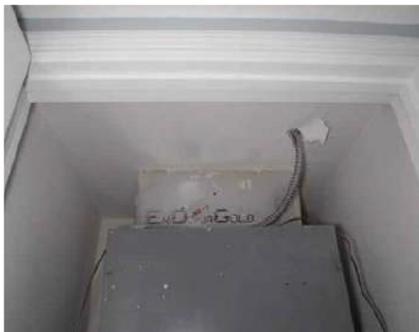
Hall bathroom above area.

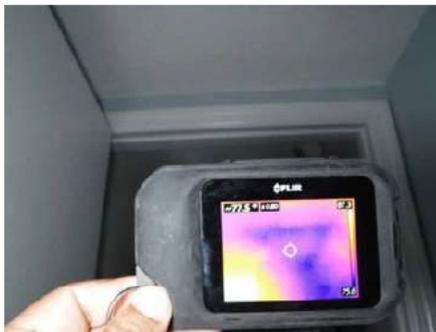
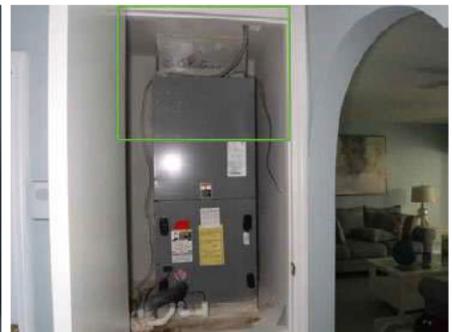
Focus area repaired
